### Determination of possible surface contamination caused by siloxanes from NOFIRNO sealant.

Report number: **89206405-01**

Date: **August 7<sup>th</sup>, 2014**

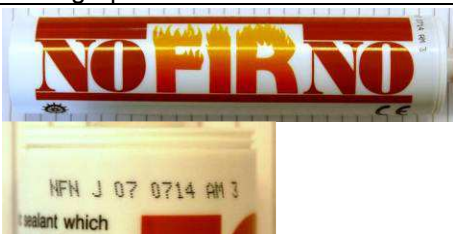
**Table 1: Sample materials, descriptions and photographs.**

TRN sample number	Sample description	Photograph
14.0089	NOFIRNO Silicone sealant NFN J 07 0714 AM 3

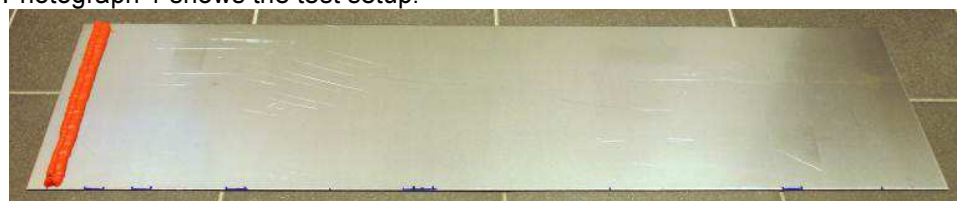
**Photograph 1: Test setup.**

35 grams of sealant was applied at a distance of 20 mm from the edge over the full length parallel to the short (250 mm) side of the metal sheet. The amount of applied sealant was determined by weighing the cartridge before and after application.

After 1 and 24 hours areas of 20 cm<sup>2</sup> on the metal sheet were sampled (in duplicate) by means of cotton balls wetted with hexane. The metal surface was sampled at a 50mm, 100mm, 200 mm, 400 mm and 800 mm distance from the applied sealant. 5 ml of internal standard solution of toluene-D8 in hexane was added to the cotton balls, which were placed in an ultrasonic bath to extract possible absorbed contaminants. The extracts were analyzed by means of gas chromatography mass spectrometry. Photograph 1 shows the test setup.

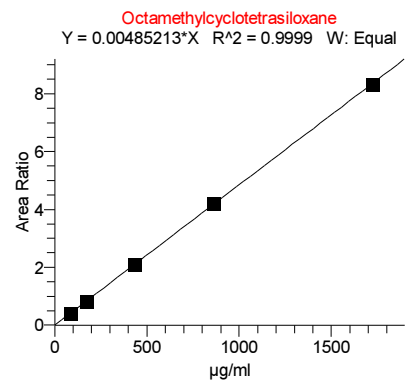
Figure 2: Internal standard calibration curve of octamethylcyclotetrasiloxane.

The GCMS chromatograms of the standard solutions are given in figure 1. The internal standard calibration curve is given in figure 2. The detected components are listed in table 2.

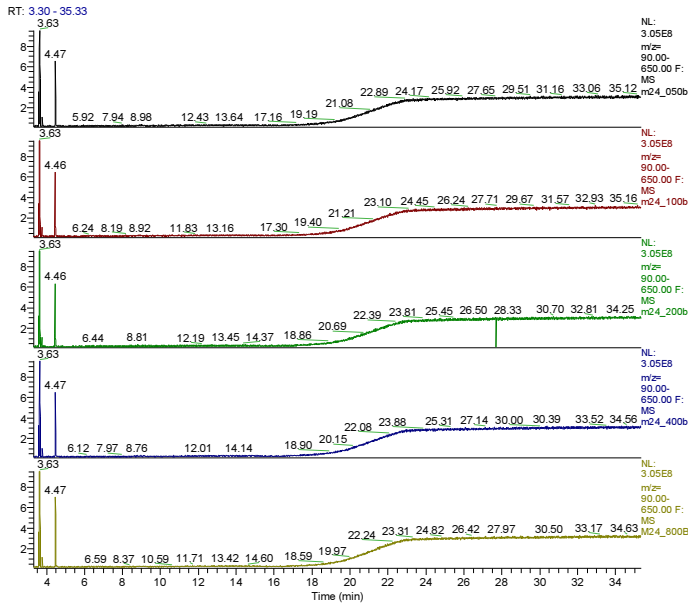
**Figure 4: GCMS chromatograms of the 24 hour samples. Top to bottom: 24h-50mm, 24h-100mm, 24h-200mm, 24h-400mm, 24h-800mm.**

The GCMS chromatograms of the samples taken after 24 hours are given in figure 4. The detected components are listed in table 4.

Apart from hexane and the internal standard toluene-d8 no volatile organic compounds were detected. The calculated limit of detection for D4 of the surface of the metal sheet is 300 µg/m<sup>2</sup>.

No volatile contaminants were detected on the surface of the metal sheet after 1 and 24 hours after the application of sample 14.0089. The detection limit of octamethylcyclotetrasiloxane (D4) is 300 µg/m<sup>2</sup>.
